# RESTORING LAKE PEDDER: A GEOMORPHOLOGICAL PERSPECTIVE ON RECOVERY PROSPECTS AND LIKELY TIME SCALES

Kevin Kiernan<sup>1</sup>

KIERNAN, K., 2001: Restoring Lake Pedder: A geomorphological perspective on recovery prospects and likely time scales; in: Sharples, C., (ed.), *Lake Pedder: Values and Restoration*, Occasional Paper No. 27, Centre for Environmental Studies, University of Tasmania, p. 153 - 176.

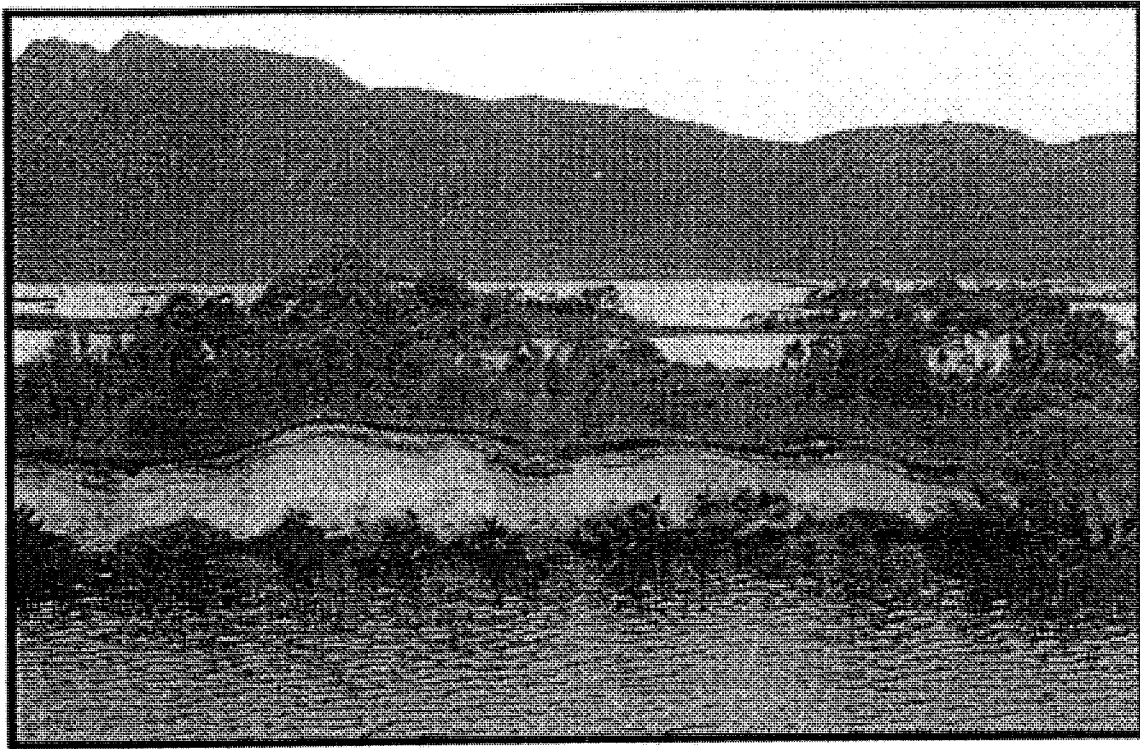
**Figure 5a:** Photograph of the dune face taken during filling of the reservoir in July 1972 when the water level was 296.5 metres, well below the new lake's final level of 308m. This photograph was used by the pro-dam lobby in the 1970s in an attempt to promote the idea that the dunes had been destroyed, and was employed again in a misleading press campaign in 1995 (see this volume p. 7). It shows trimming but no fundamental change to the natural morphology of the dune face.

Drawdown therefore needs to occur as rapidly as possible when, and shortly before, the dune face is exposed. If possible, it should be timed for when conditions are least likely to be stormy so that wave action is at its least, and for when the receiving rivers are naturally at low stage so that downstream damage is avoided. Erosion around the perimeter of the Huon - Serpentine Impoundment as the water level drops is likely to be minimal provided drawdown is achieved reasonably rapidly.

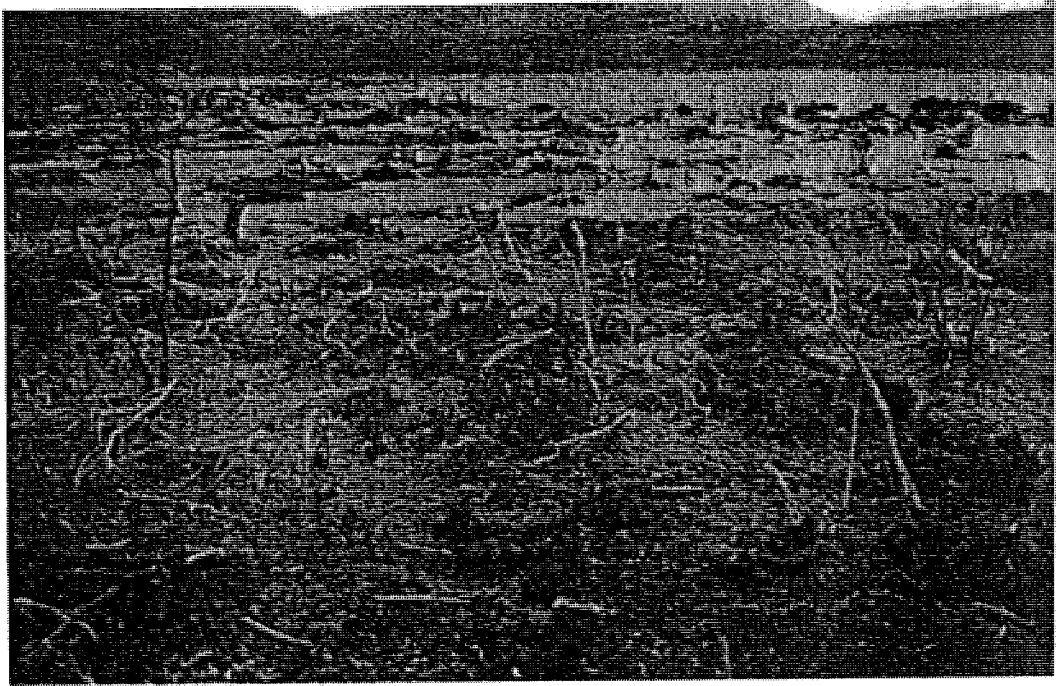
**Figure 6:** Degree 2 damage to reservoir perimeter. Inundation has killed the vegetation but wave action on the shallow lake margin has been insufficient to fragment the root mat and peat more than two decades after the reservoir was filled (photo: K. Kiernan, 1999).

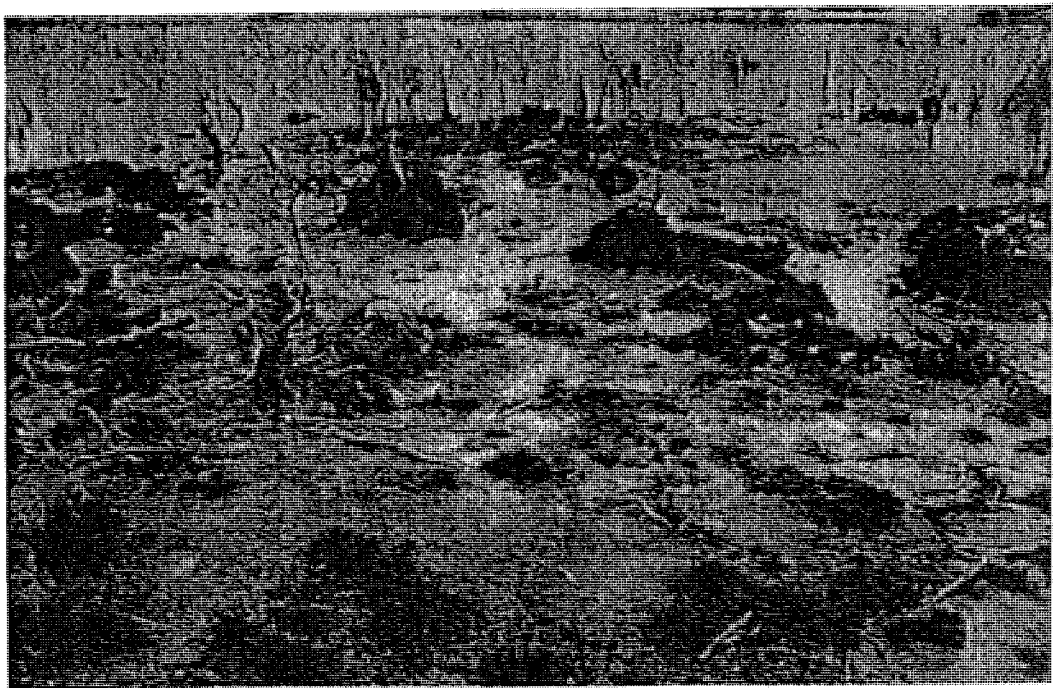
**Figure 7a:** Degree 3 damage. Minor peat erosion in an embayment on the reservoir perimeter. The limited erosion and frequent exposure here allows some of the remaining vegetation to remain alive (photo: K. Kiernan, 1999).

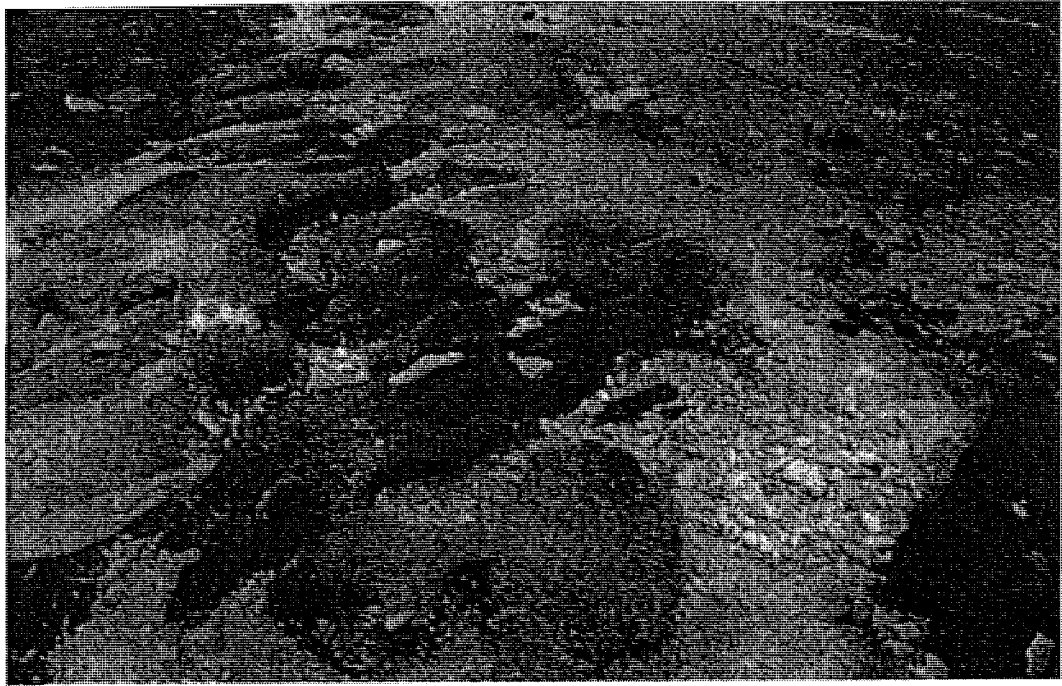
**Figure 7b:** Degree 3 damage. The pattern of peat erosion here involves the development of shallow channels up which gravels are swept and deposited on the peat further inshore. In more severely affected areas confluence of the erosion channels proceeds to the formation of remnant peat islands (photo: K. Kiernan, 1999).

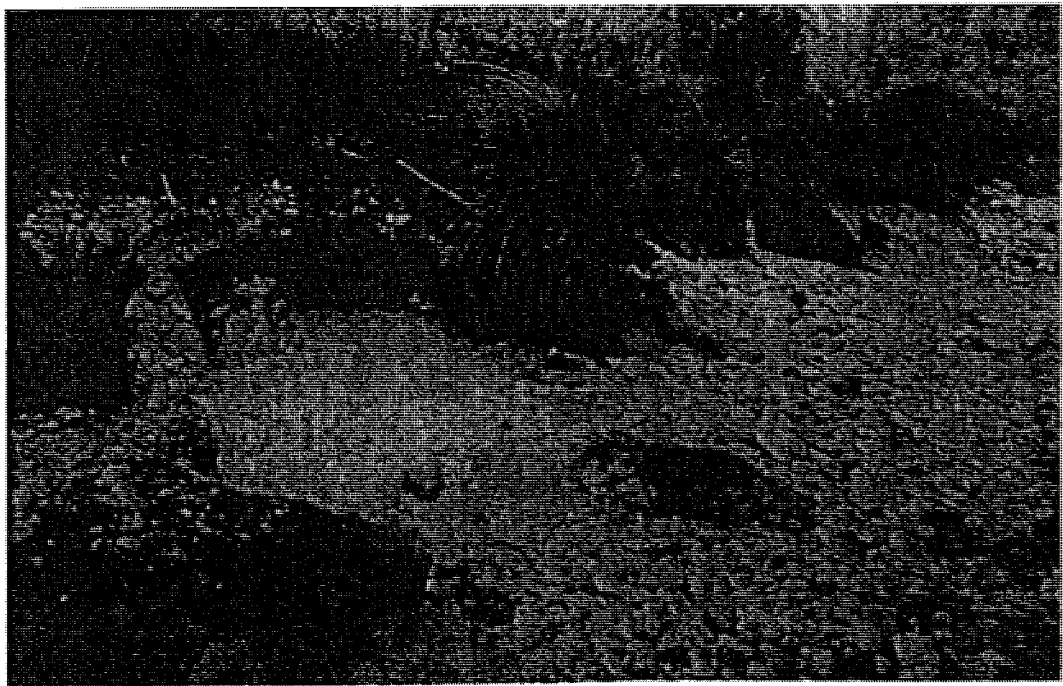
**Figure 7c:** Degree 3 damage. Cliffling of sandy regolith in embayments between remnant peat promontories (foreground). Minor tunnelling in loose regolith beneath peat at head of embayments (photo: K. Kiernan).

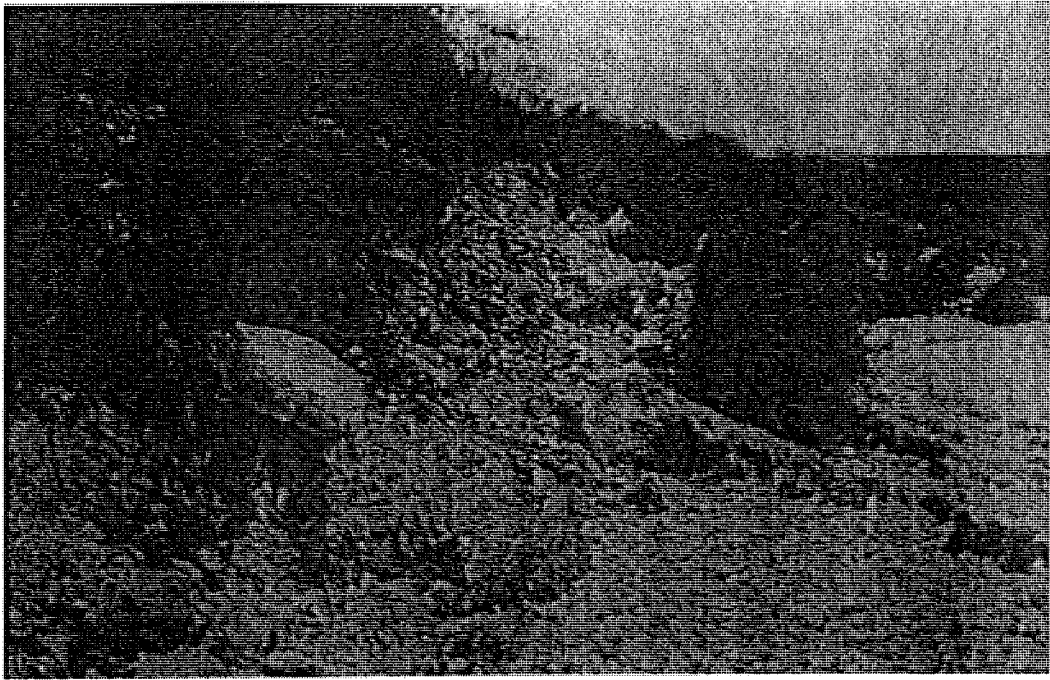
**Figure 8a:** Degree 4 damage. Scarp about 1m high eroded in surficial sediments overlying bedrock on a steep, exposed shore. Loose material from the regolith has been drawn down onto the lake margin by backwash. Deeper erosion is inhibited by the shallow bedrock (photo: K. Kiernan).

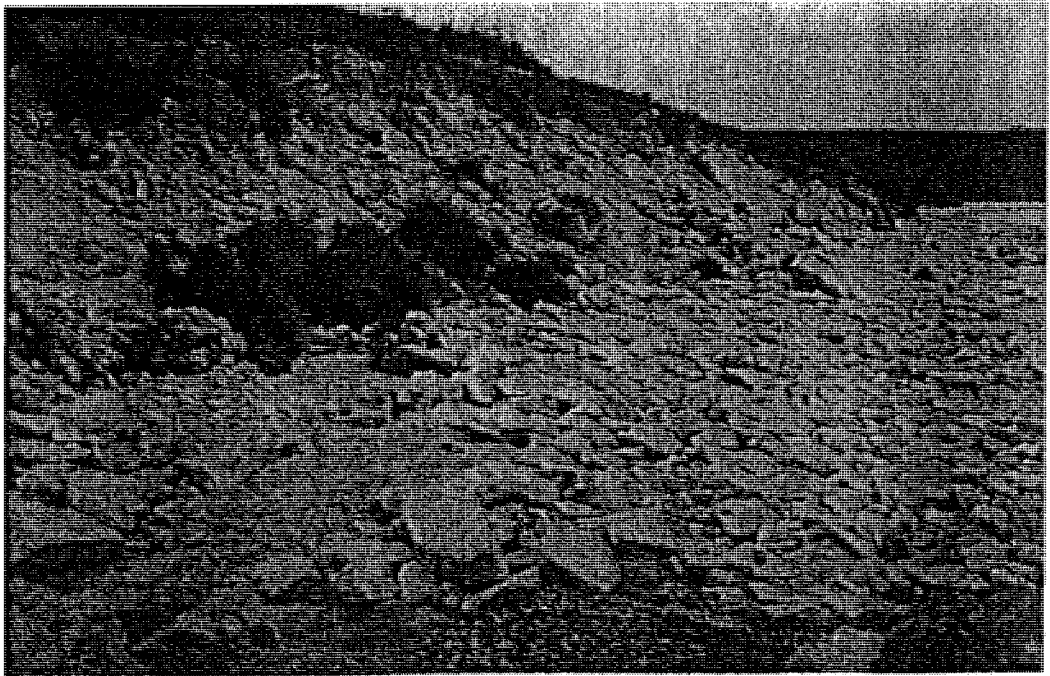
**Figure 8b:** Degree 4 damage. Scarp 2 - 3m high formed entirely in surficial sediments east of Scotts Peak Dam. This major cliffing is at the most severely eroded site identified during this survey, and is located at the exposed southern end of the reservoir. The blocks and cobbles in the foreground have been reworked from the regolith with the larger rocks piled towards the back of the beach by wave action (photo: K. Kiernan).

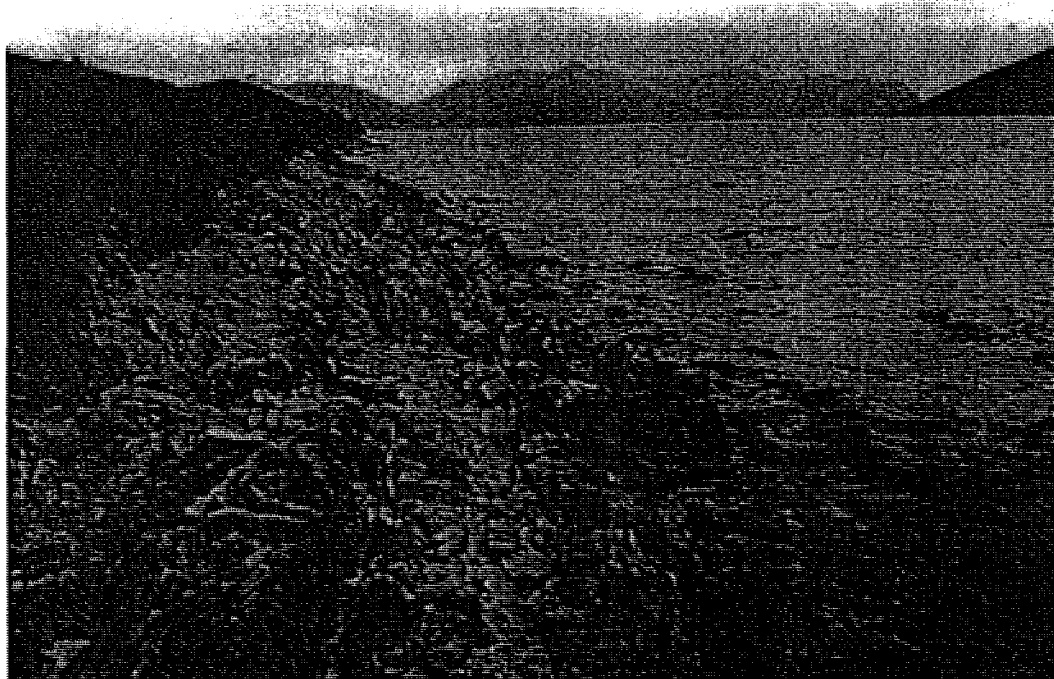
**Figure 8c:** Degree 4 damage. Stripping of shallow peat to expose a bedrock shore on a steep margin of the reservoir west of the Scotts Peak Dam exposed to the full fetch of the largest waves (photo: K. Kiernan).

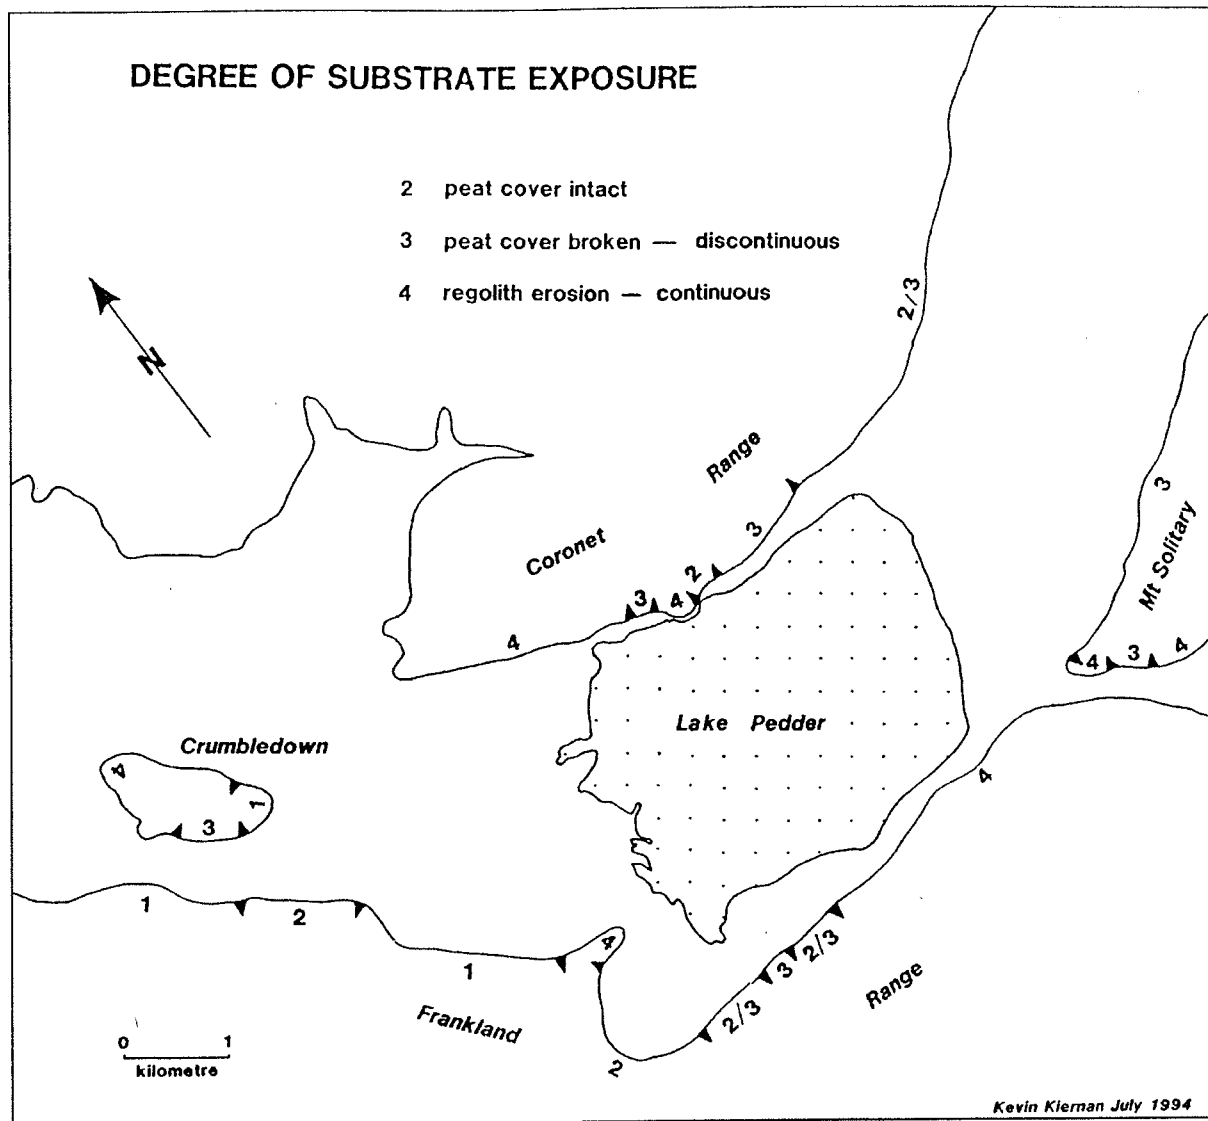
**Figure 9:** Reconnaissance map of erosion severity around the perimeter of the Huon-Serpentine Impoundment in the vicinity of Lake Pedder.

The most serious damage caused by wave erosion are the degree 4 areas at Terminal Peak, the present Cripps Point and at Crumbledown. Degree 4 scarring represents only ~20% of the impoundment margins visible from Pedder Beach, or at most 30% taking into account the most serious sites within degree 3. Given the limited vertical amplitude of the wave eroded zone, and remembering that the air photo interpretation does not accurately represent the gradient on the ground, a better impression can be gained by relating the air photo observations to the gradient evident from maps and from photographs taken from the valley floor and beach. This latter exercise suggests that, from an aesthetic perspective only, when the dams are first drained serious scarring will be visible from Pedder Beach in only a limited number of areas and often at a considerable distance. The highest visual impact is likely to be the scarring on Terminal Peak. The other significantly scarred areas in the viewfield from the beach will be 4 km distant in the case of

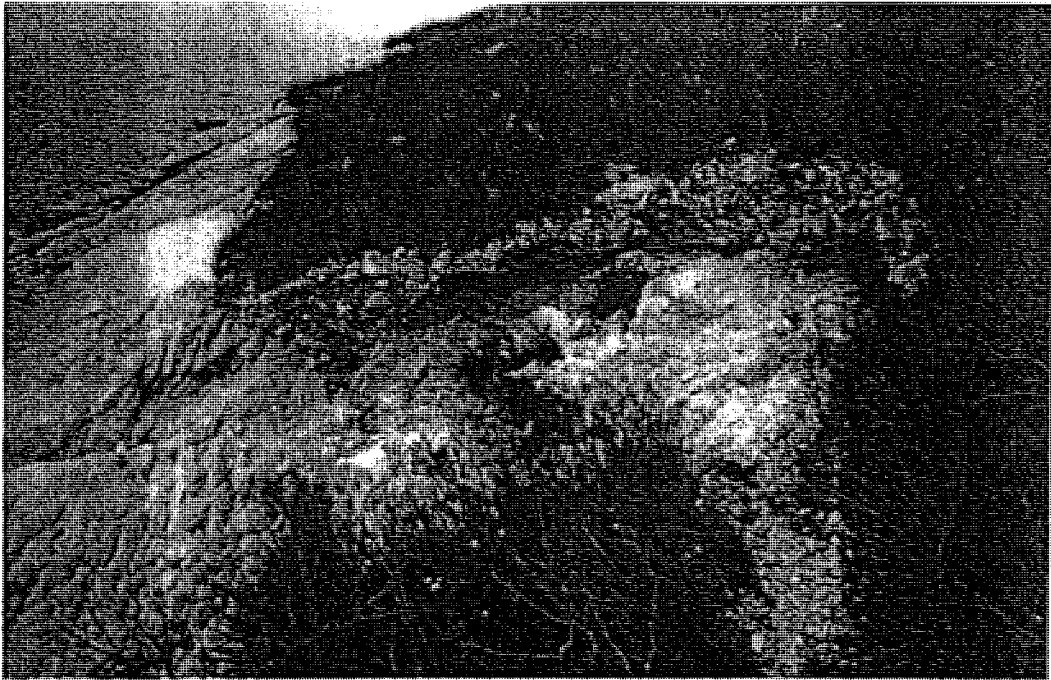
caused landslides that have migrated upslope (Figure 10). This is due to the generally low angles and lengths of the slopes and to the nature of the component clasts and matrix of the surficial sediments. Since these have been stripped to well above the surface of the impoundment there is no evidence to suggest that the water itself provides any sort of buoyant support to the material that would be lost when the dams are drained, threatening slope failure.

**Figure 10:** Small landslide on reservoir perimeter west of Scotts Peak Dam, caused by wave erosion removing toe support from slope deposits. Slope failures of this kind appear uncommon around this reservoir (photo: K. Kiernan).

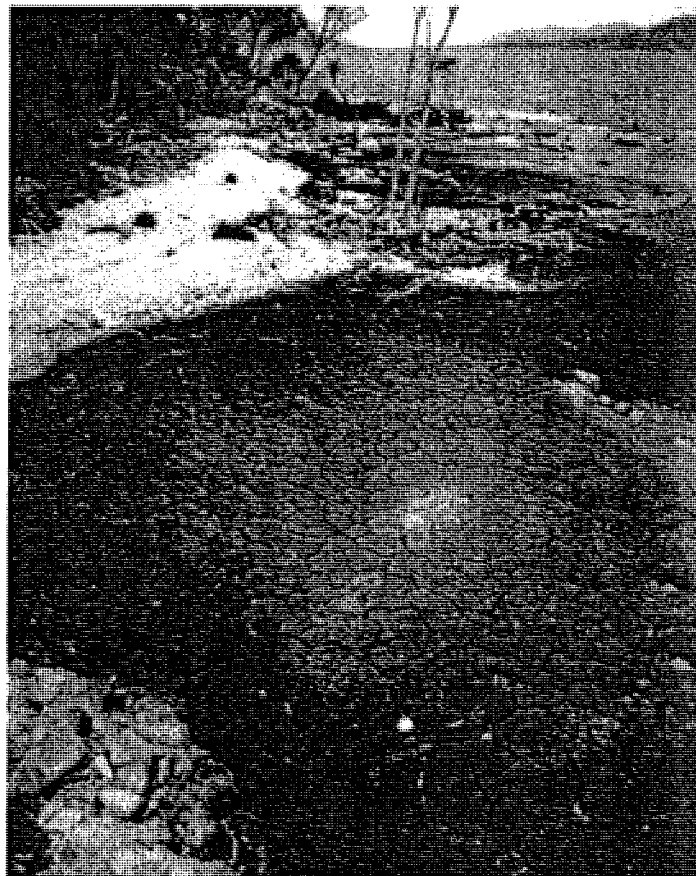
The exposed peat has sometimes become patterned by desiccation cracks (Figure 11a), which are likely receptacles for seed and nutrient capture and hence foci for revegetation when the reservoir is drained. A similar pattern of regrowth from peat desiccation cracks has been observed on the floor of Lake King William and some other artificial reservoirs when their floors have been exposed during protracted periods of lake drawdown.

**Figure 11a:** Peat soil survival despite an appearance of erosion. Intact peat on the southern perimeter of the impoundment. Despite apparent exposure to the full fetch down the lake the shallow shore reduces wave action. The intact peat exhibits desiccation cracks that can form receptacles for seeds and nutrients. The white material inshore of the peat is not regolith exposed by peat erosion, but merely a thin veneer of gravel deposited on the peat by wave action. The presence of gravels implies they have been eroded from elsewhere. Since there is no erosion of the peat on the shore it is likely that longshore drift has been involved, but erosion from deeper water forward of the peat cannot be discounted entirely (photo: K. Kiernan).

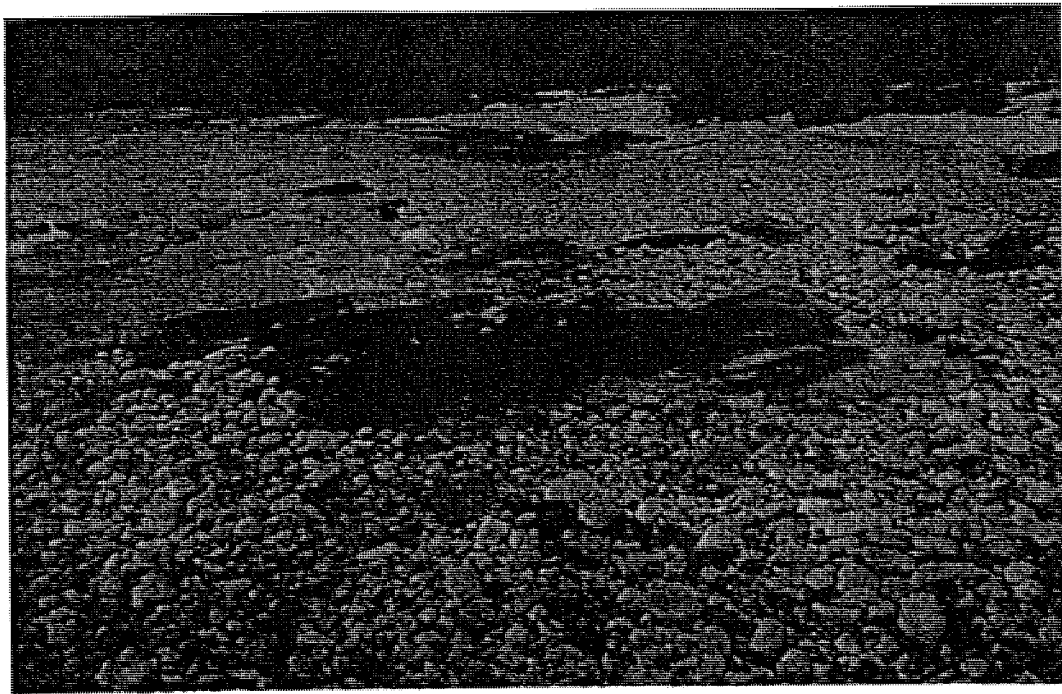
**Figure 11b:** Intact peat thinly overlain by gravels and cobbles deposited by waves along the exposed southern margin of the impoundment. Again, the peat remains available as a potential growth medium for plants when the impoundment is drained (photo: K. Kiernan).

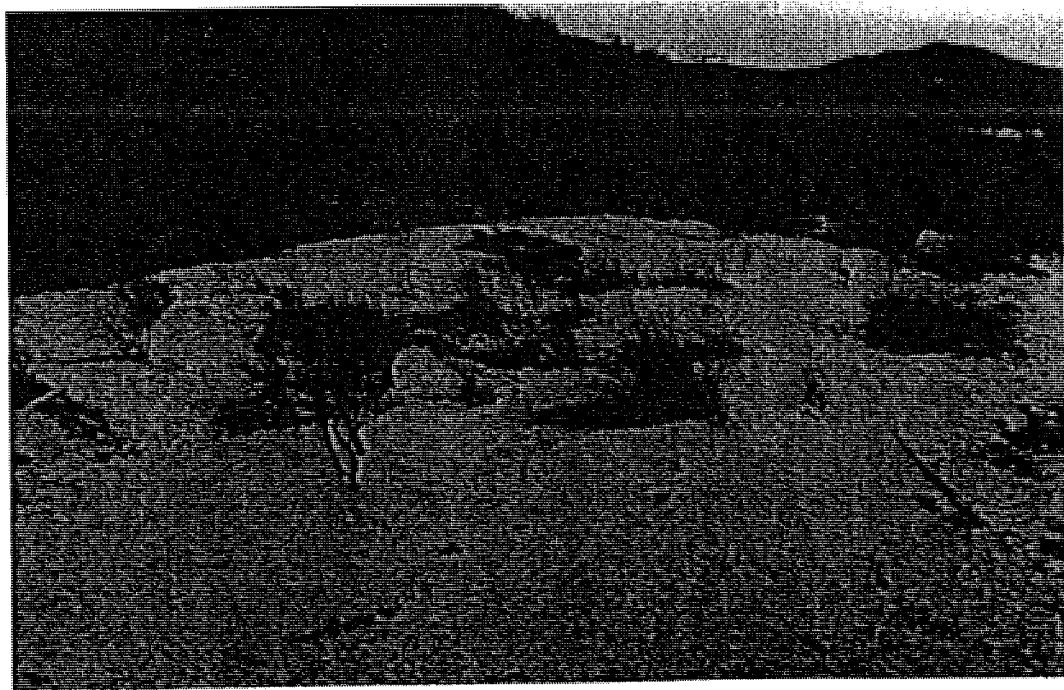
**Figure 11c:** Formation of small beach ridges has here involved the dumping of gravels on living vegetation by wave action. Again the eroded appearance is deceptive, and a viable medium for plant growth remains intact beneath the sediment. Similar small storm-beach ridges encroaching onto living vegetation could be found along parts of the southern shoreline of the original Lake Pedder. The coarse calibre of the lakeshore sediment in this and earlier photographs is typical, and in contrast to pre-dam promises that sandy beaches equivalent to that at the eastern end of the original lake would rapidly form to replace it. This was never a serious proposition because the source of the Pedder beach was fine wind-deposited sand naturally eroded from the face of the Pedder dune each winter and spread onto the floor of the original lake basin. No similar large source of windblown sand is available around the margin of the artificial Huon-Serpentine Impoundment (photo: K. Kiernan).
